Supplement to H-58-MIM-11-002 Left and Right Tailboom Fittings

Upper Tailboom Attachment Fitting – Damage Limits (OH_206032_159_1_J3522)

Longerons - Center and Upper Fuselage - Damage Limits (OH_406032_75_J3522)

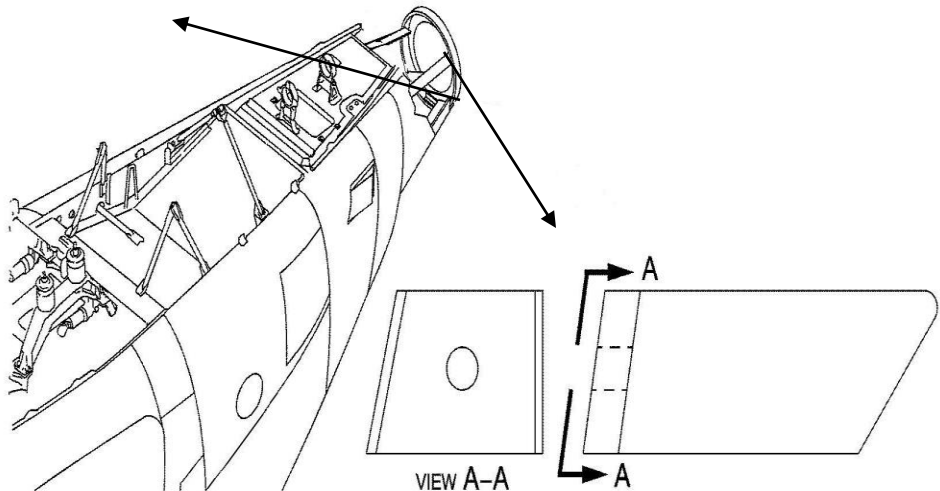
206032-159-1
J3522

TYPE OF DAMAGE	MAXIMUM DAMAGE AND REPAIR
MECHANICAL AND CORROSION	0.010 in. before and 0.020 in. after repair
MAXIMUM AREA PER FULL DEPTH REPAIR	0.250 sq. in.
NUMBER OF REPAIRS	Maximum one repair per part
EDGE CHAMFER	0.010 in. x 45°
MOUNT BOLT BORES	0.020 in. after repair

NOTE: No cracks are permitted.
All parts are corrosion prone.

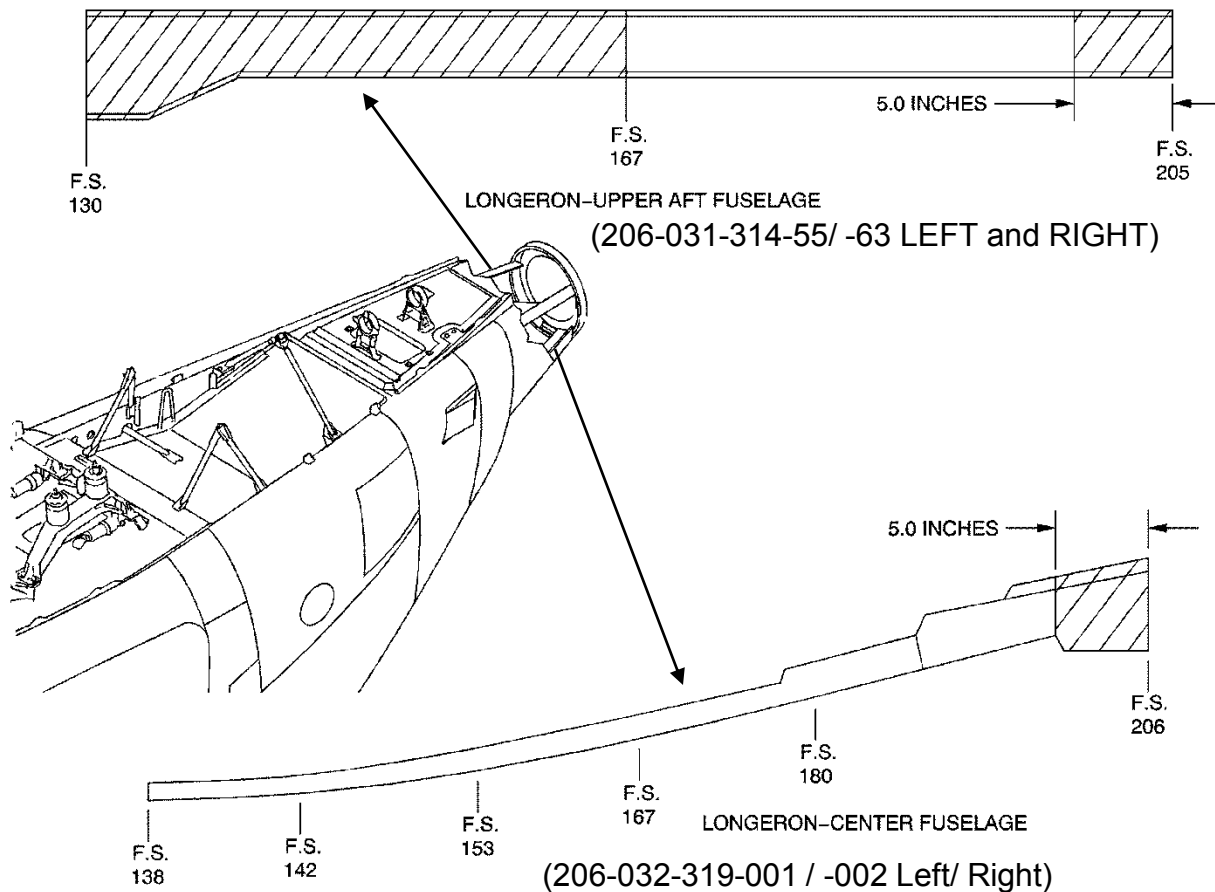
406032-75
J3522

None allowed
None allowed

0.002 in. before repair
0.004 in. after repair

0.50 sq. in.

One per part

0.010 in. x 45°

NOTE: All parts are corrosion prone.
