SUPPLEMENT TO H-58-10-ASAM-04

CYCLIC PIVOT SUPPORT

SUBJECT: 206-001-397-XXX CYCLIC SUPPORT ASSEMBLY; MAINTENANCE AND INSPECTION OF.

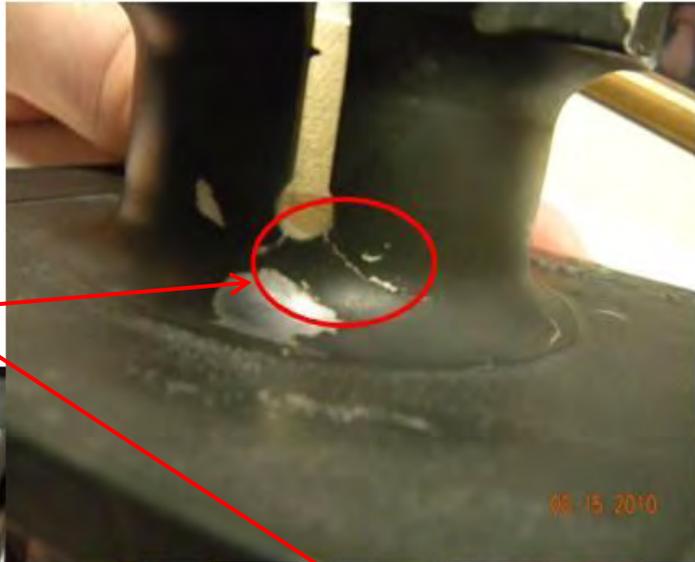
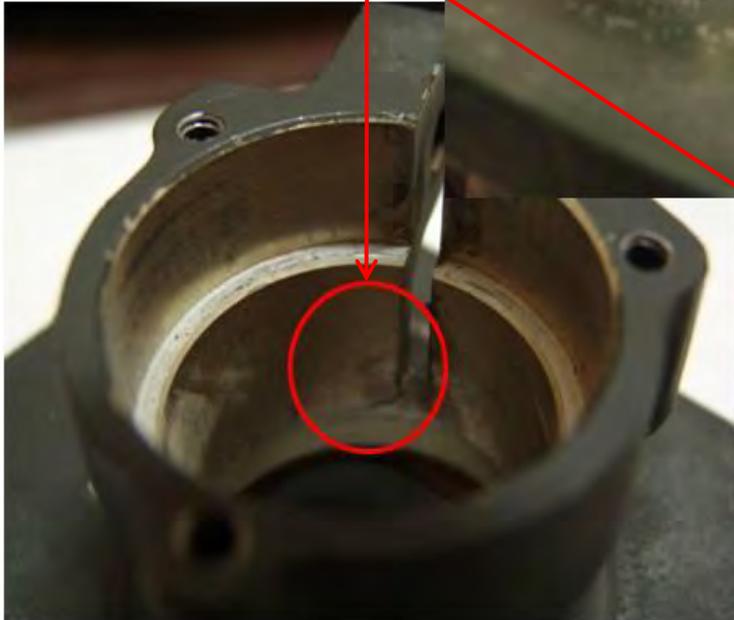
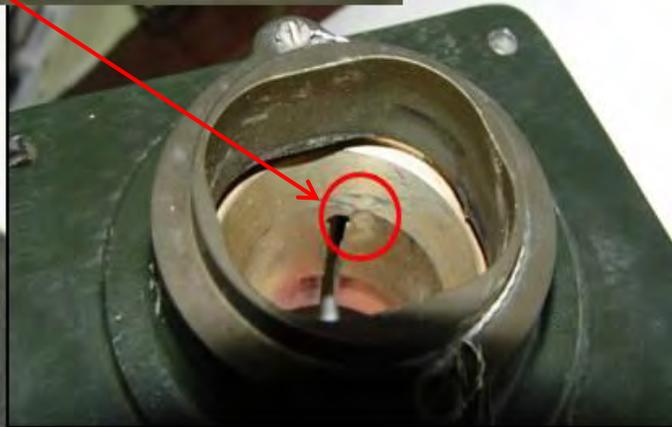
Examples of
cracking.

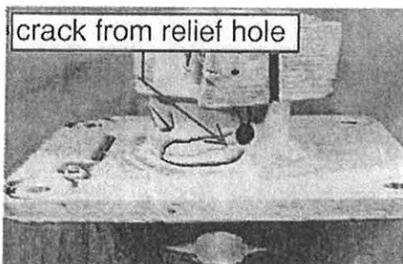
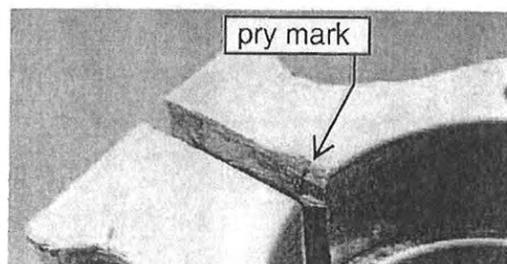
This Operation Safety Notice is issued to emphasize the importance of using the correct procedure while removing or installing parts on helicopters. Based on recent reports where cracks were found on Cyclic Pivot Support (all made from 206-001-360 casting), Bell Helicopter would like to remind owners/operators to pay particular attention to the note written in the applicable section of the maintenance manual specifying "not to use a screwdriver or wedge of any type to spread the slot in the pivot support to aid in the installation/removal of the split friction bearing. Spreading the slot results in excessive stress in relief hole of the slot which could cause overload cracks." Supports exhibiting cracks are determined unserviceable.
