**OH-58-10-AMAM-05  
BORESCOPE INSPECTION  
CABIN ROOF BEAM/PYLON SUPPORT AREA  
OH-58D**

## Addendum 2 to H-58-10-AMAM-05

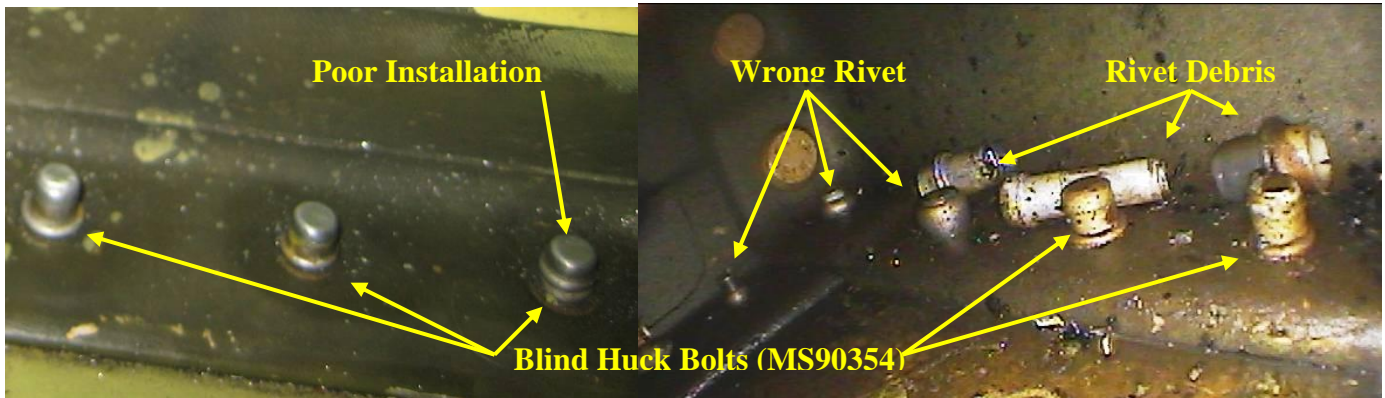
Figure 2, Fastener Examples

- a. Inspect the blind head of MS series blind bolts for grip engagement. Even though the pin shears flush and the lock ring engages, these rivets may not clamp with a sufficient grip. The predominant fastener used in this structure is a MS90354 (Refer to AMAM Addendum for correct fastener callouts). Blind rivet debris should be removed from the beam interior following repairs. MS series blind bolts are ferrous steel and can be retrieved magnetically. (Fig 2)

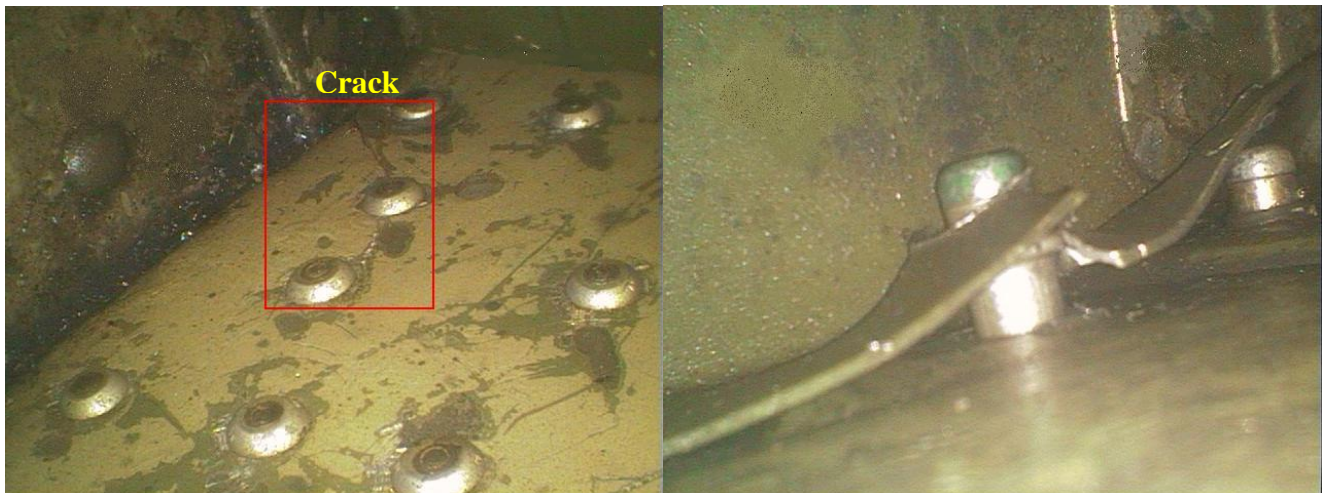
Figure 3, Damaged P/N 206-032-200-21, Thin Bulkhead

- b. Inspect interior bulkheads for cracks. Cracks can originate from fastener holes that have insufficient edge distance (ED) due to oversized rivet selection, or poor hole preparation following repairs. Based on the thin design, the P/N 206-032-200-21, Bulkhead, is easily damaged when replacing fasteners in the P/N 406-530-100-131, Channel. (Fig 3)

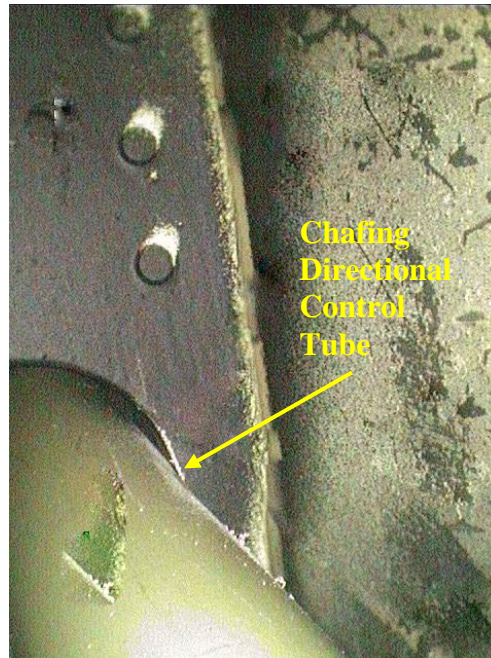
Figure 4, Chafing, P/N 206-001-020-33, Connecting Link

c. Inspect for directional control tube clearance at each bulkhead pass through. Bulkhead replacement or repair can cause chafing. Additionally, inspect for damage caused by errant drill bit engagement following repairs. (Fig 4)

Use care not to nick or gouge the connecting link during probe insertion. If connecting link is damaged refer to TM 1-1520-248-23 for inspection and repair limits.

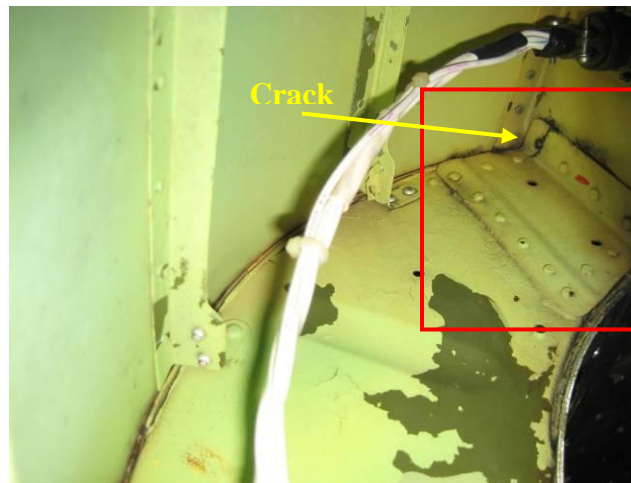
Figure #, P/N 406-032-302-51, Splice, FS 130

10. Insert bore scope probe from access panel forward through lightening hole in the P/N 206-032-303-1, Frame, at FS 142. In addition to condition and security of the FS 130 Bulkhead, inspect the P/N 406-032-302-51, Splice, for cracks and loose rivets.
