ADDENDUM TO H-58-12-ASAM-04
LONGERON CRACKING
Upper Left and Right Side Longeron Inspection
Part Number (PN) 206-031-314-55/63

This Addendum is required for use in conjunction with OH-58-12-AMAM-XX.

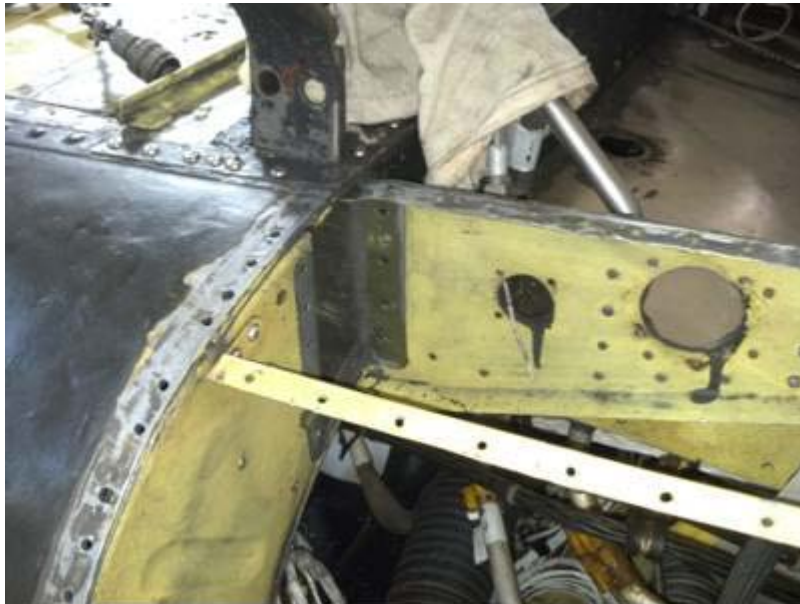
Figure 2: Inspect for cracks along edge of angle and at rivet locations

8. Slide heater tube aft to gain access for inspection. Utilize a flashlight and mirror to look through cabin heater fresh air intake opening; inspect aft side of FS 130 bulkhead/ left longeron for presence of cracks. Pay particular attention to areas around fasteners, doublers and angles. (For example of crack, refer to figures 2 and 3).

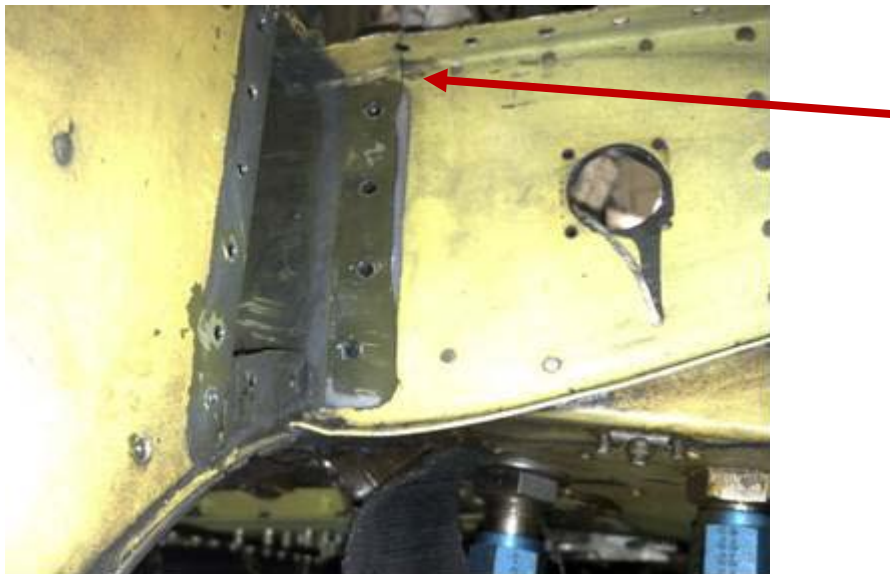
Figure 3: Example crack at fastener location, angle removed.

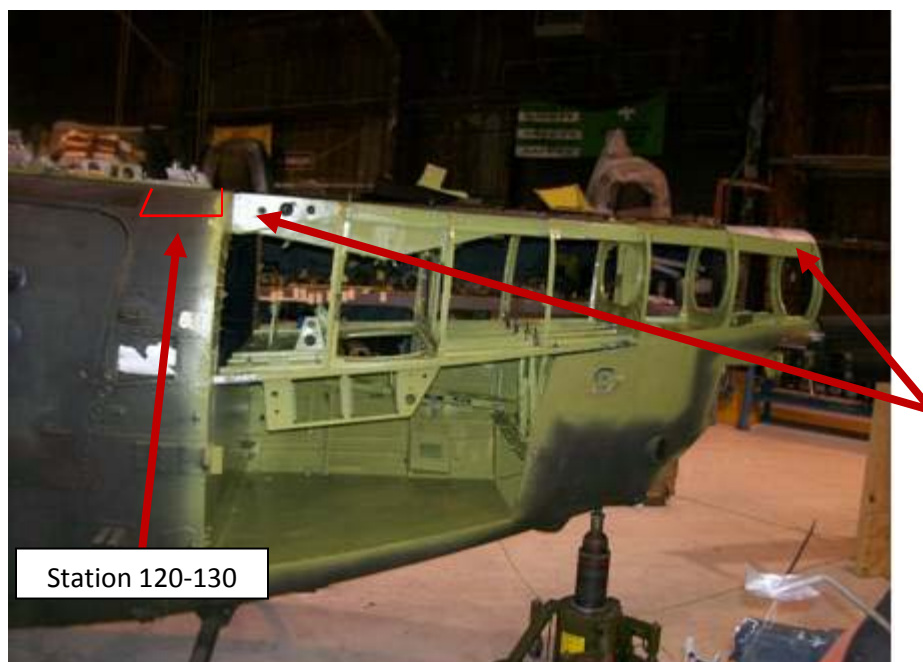
Figure 4: Left side cut away showing longeron from Station 130 bulkhead to tailboom fitting.

9. Using flashlight and mirror inspect remaining area of left side longeron and visible portions of the right side longeron for presence of cracks. The aft portion of the left longeron will be inspected from right side panels 13 and 38.

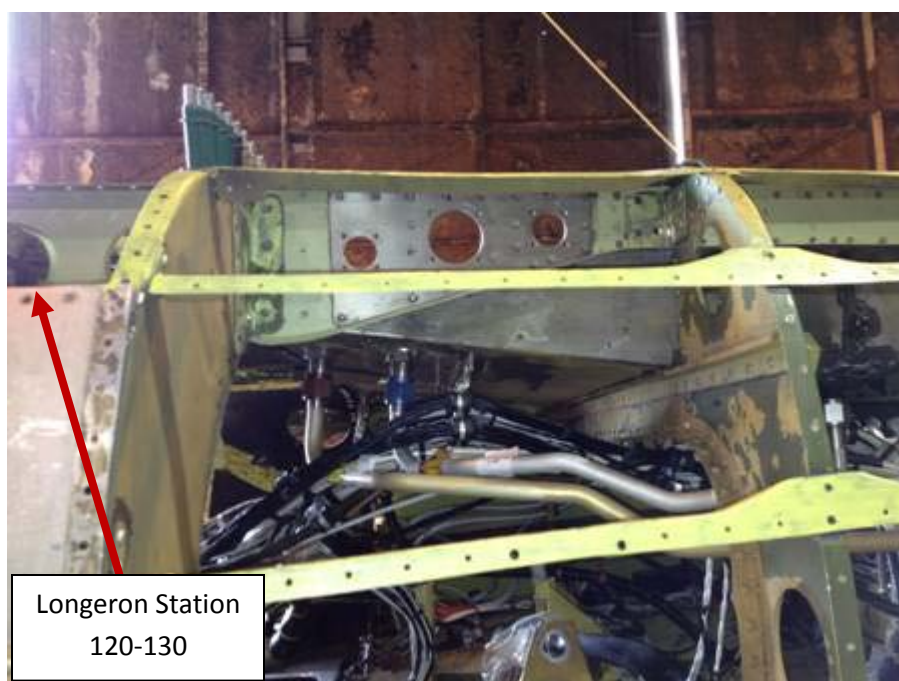
Figure 5: Cutaway left side longeron at FS 130 bulkhead
Longeron Inspection Right Side (PN 206-031-314-55)

3. Remove fuel pressure switch access panel 33.
4. Remove small upper access panel that is located inside panel 33(see Figure 5).
5. Remove left and right side Aft Pylon Support strap access panels 57.

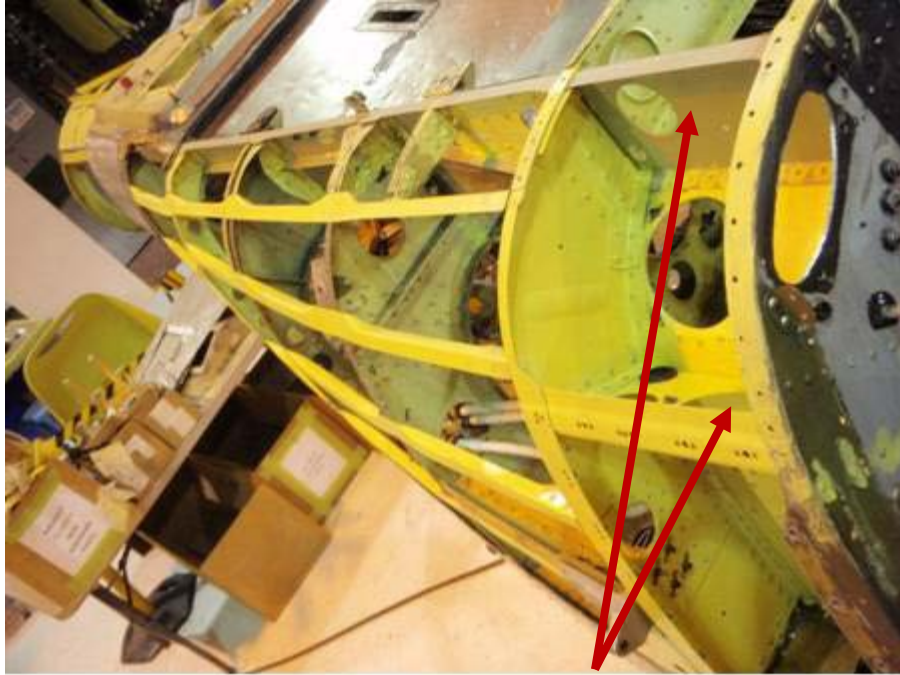
**Figure 6: Cutaway view of the right longeron. Top arrow: FS120 to 130 longeron area.
Bottom arrow: Small access area inside panel 33.**

10. Starting at right side fuselage station 120/130 bulkhead, using a Borescope inspect longeron through access panel 33 (see Figure 6). Inspect longeron area between FS 120 and 130 for presence of cracks. Pay particular attention to areas around fasteners, doublers and angles.

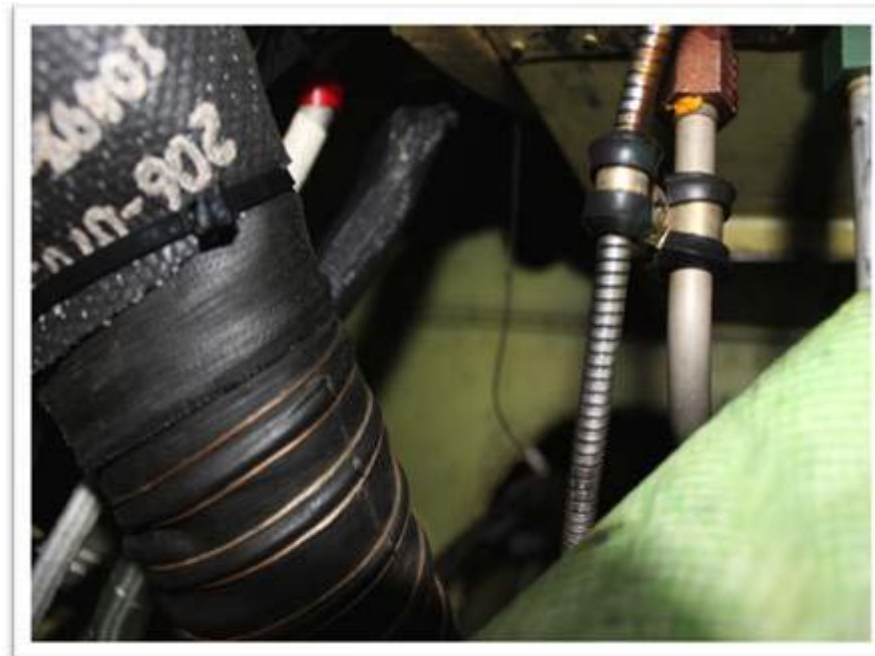
Figure 7: Access to right side station 130-140 through cabin soundproofing (follow wiring up to engine deck and scope fore and aft of wiring)

11. Insert Borescope probe through right side cabin sound proofing and up along side of the ECU wire harness. Inspect longeron area between FS 130 and 140 for presence of cracks. In order to inspect all of the longeron, the borescope will have to be manipulated around the engine wire harness bulk head connection. Pay particular attention to areas around fasteners, doublers and angles.
