ADDENDUM TO H-58-09-AMAM-03  
Tail Rotor (TR) Driveshaft Alignment Check

**6-6-4. Aft Short Shaft Assembly -Removal/Installation**

**6-6-6. Coupling Disc Pack -Removal/Cleaning/Installation**

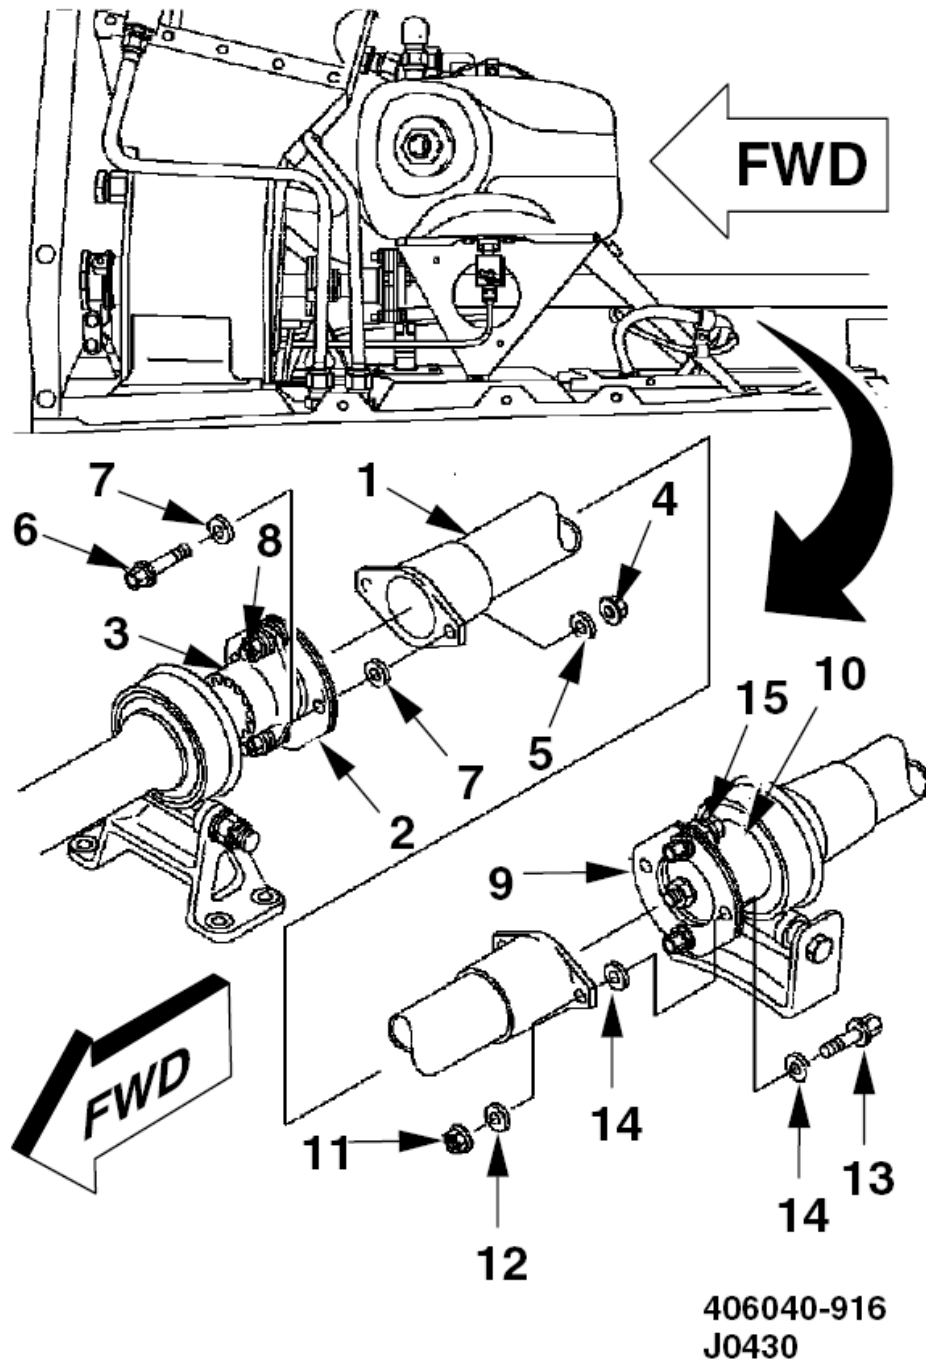
1. Gain access to aft short shaft assembly (1) by opening tail rotor driveshaft cover.

2. Break torque on eight nuts (4), (8), (11), and (15).
3. Disconnect forward end of aft short shaft assembly (1) from coupling disc pack (2) on adapter (3) by removing two nuts (4), two flat washers (5), two bolts (6), and four beveled washers (7).
4. Disconnect aft end of aft short shaft assembly (1) from coupling disc pack (9) on driveshaft assembly (10) by removing two nuts (11), two flat washers (12), two bolts (13), and four beveled washers (14).
5. Remove aft short shaft assembly (1).
6. DELETED
7. Clean, inspect, and repair aft short shaft assembly (1) (Task 6-6-5).

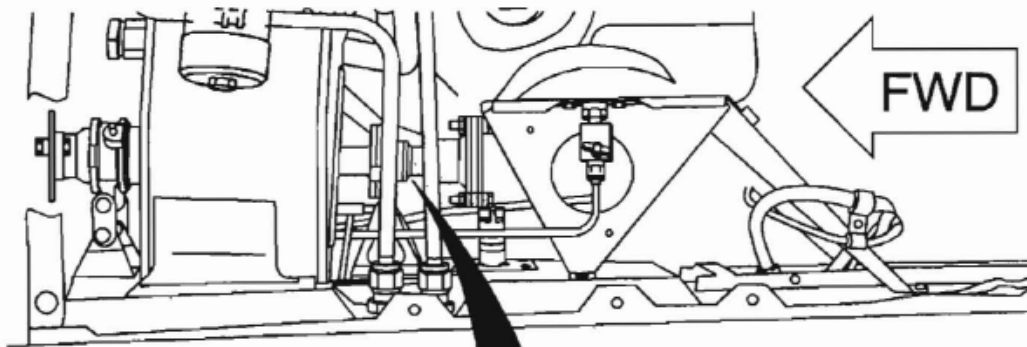
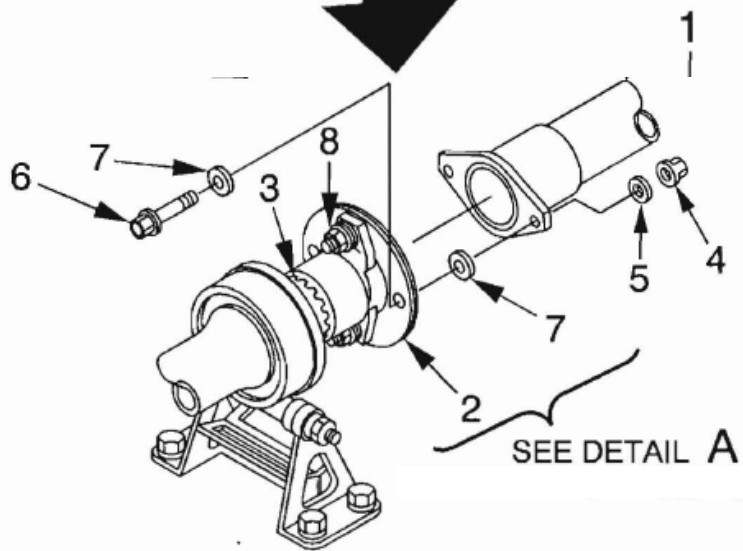
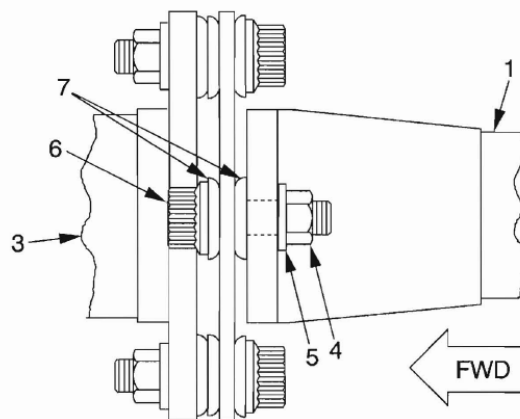
DETAIL A  
(CORRECT HARDWARE CONFIGURATION)

Installation of beveled washers with rounded edge against coupling disc packs and correct torquing of nuts are characteristics critical to flight safety. If beveled washers are installed incorrectly, damage to coupling disc packs will result.

8. Connect forward end of shaft assembly (1) to coupling disc pack (2) on adapter (3) by installing two bolts (6), four beveled washers (7), two flat washers (5), and two nuts (4).

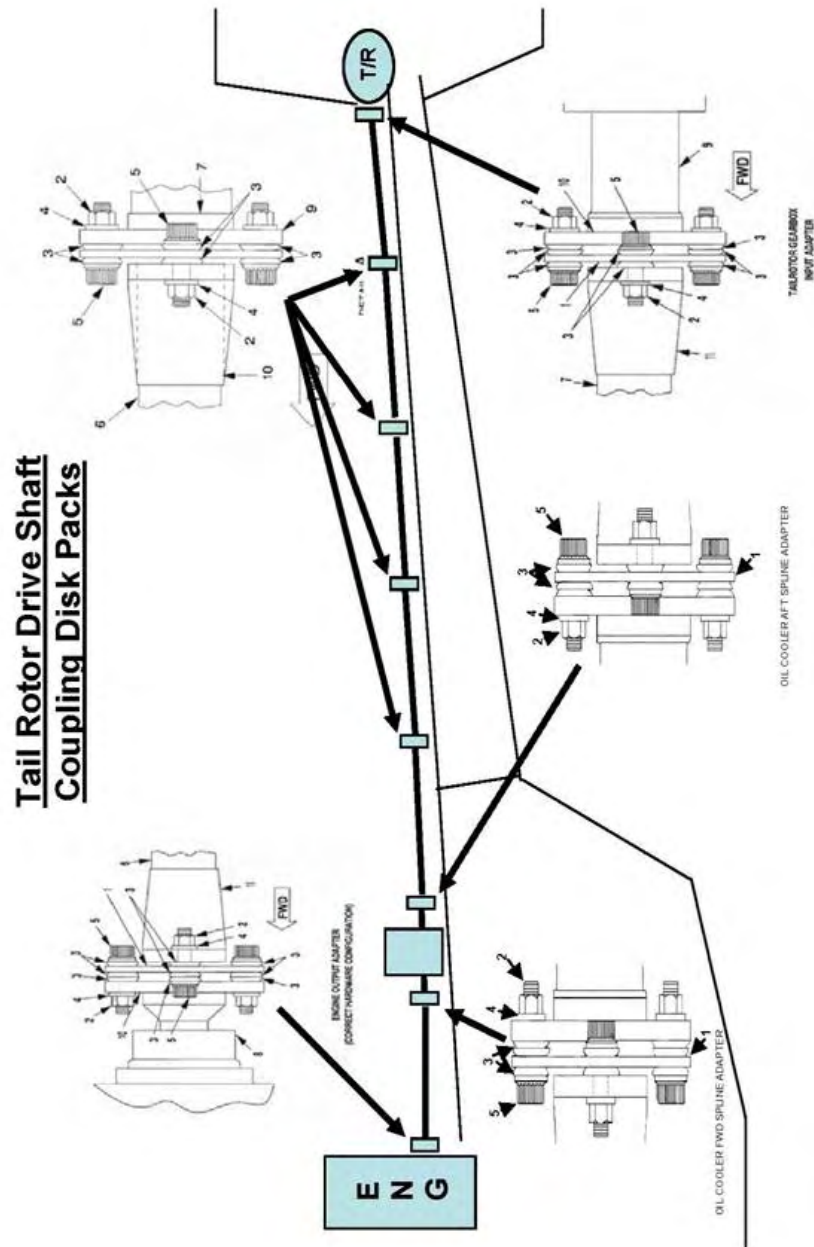
2. Clean discs with drycleaning solvent (D-80) and wiping rags (D-195). Follow-up with a denatured alcohol (D-41) wipe using a clean rag.

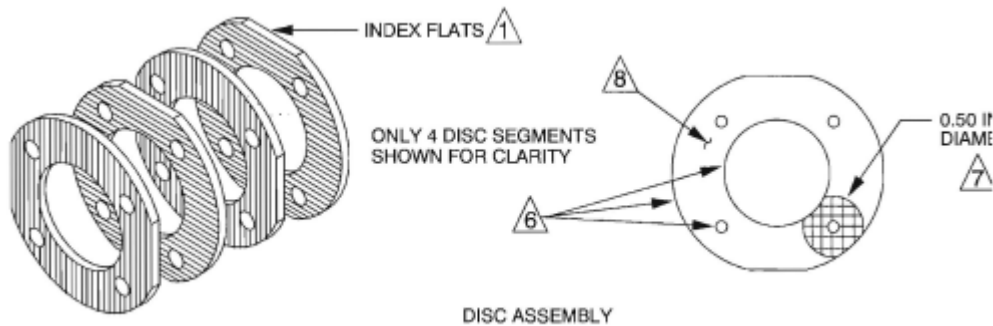
MAKE SURE THAT THE ORDER IN WHICH THE DISC SEGMENTS ARE STACKED DOES NOT CHANGE AFTER THE COUPLING DISC PACK HAS OPERATED.

3. Use solvent (MIL-PRF-680) to clean grease and oil from each disc segment. Follow-up with a denatured alcohol (O-E-760) wipe using a clean rag.
4. Use a soft rubber eraser to clean fretting corrosion.

5. Cracks, nicks, and scratches are not permitted.
- 6 No fretting damage is permitted in less than 0.050 inch from an edge.
7. Discard disc segments that have fretting corrosion of more than 0.001 inch deep and on more than 40 percent of the area (4 places each side). Damage of 0.001 inch can be felt with a 0.010 inch spherical radius probe.

8. Random light fretting corrosion is permitted if corrosion is not on more than 5 percent of each quadrant, and each pitted area is not more than 0.005 inch in diameter and 0.001 inch in depth. Damage of 0.001 inch can be felt with a 0.010 inch spherical radius probe.

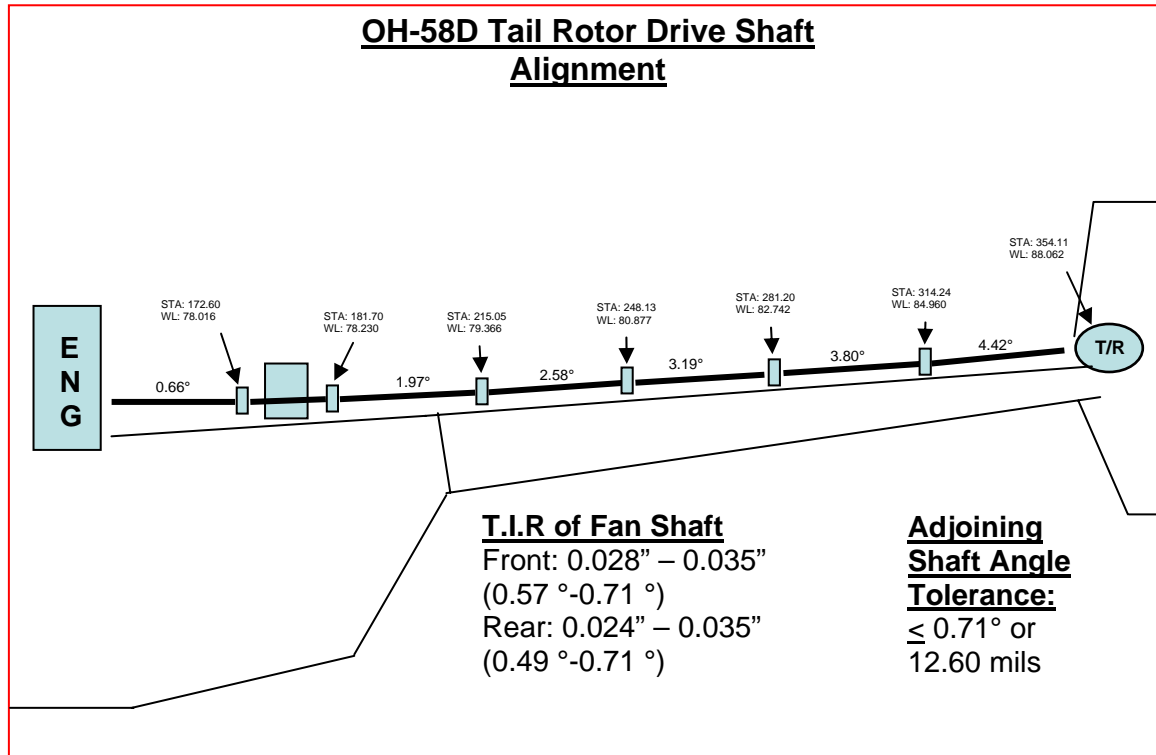
- The angles listed above each shaft in the above figure are for reference only. These angles represent an optimum spread, and do not account for variations within each aircraft.
- Alignment and numbering of the shafts progress forward from the tail rotor gearbox. This numbering also holds true to the hanger bearings, brackets, couplers, etc...

c. The difference in angles between two adjacent driveshaft assemblies shall not exceed **12.60 milliradians (mils) (0.71°)**. Record angles measured in milliradians or hundredths of degrees. If difference in reading between two adjacent driveshaft assemblies (4) exceeds limits, bearing hanger support shims (6) shall be removed or added to acquire correct angle.

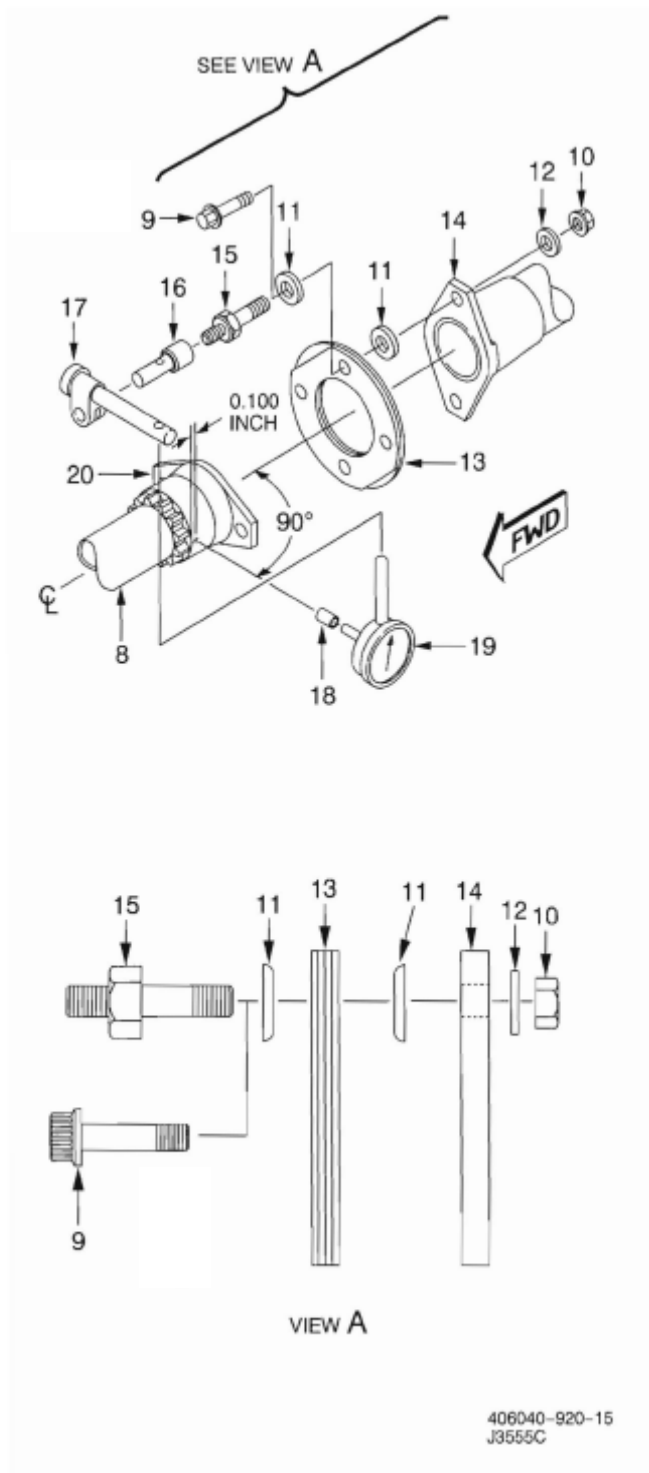
h. Using an inspection mirror to read dial indicator (B-44) (19), slowly rotate fan shaft (8) until indicator stem is contacting lower side of shaft and the indicator needle stops and reverses direction. By rotating the indicator face, zero the indicator at the reversal point. Continue to slowly rotate fan shaft (8) until indicator stem is contacting the upper side of the shaft and the indicator needle again stops and reverses direction. Record reading. If reading is not within limits, take no remedial action until coupling at opposite end of fan shaft (8) is checked.

- Maximum allowable indicator reading **0.035 inch** (0.71°).
- Minimum recommended indicator reading **0.024 inch** (0.49°).

- Care shall be exercised in reading dial indicator. Stem shall always be more depressed (clockwise needle motion) at top of total indicator reading (T.I.R.) sweep than at bottom. This will avoid reversing curvature of driveshaft. With angles as small as 0.6°, the eye cannot readily detect whether angle is up or down.
- A maximum sweep indication at other than the 12 o'clock position is indicative of a lateral misalignment. Limited play between the hanger bracket hardware and the deck inserts allow for minor lateral corrections.

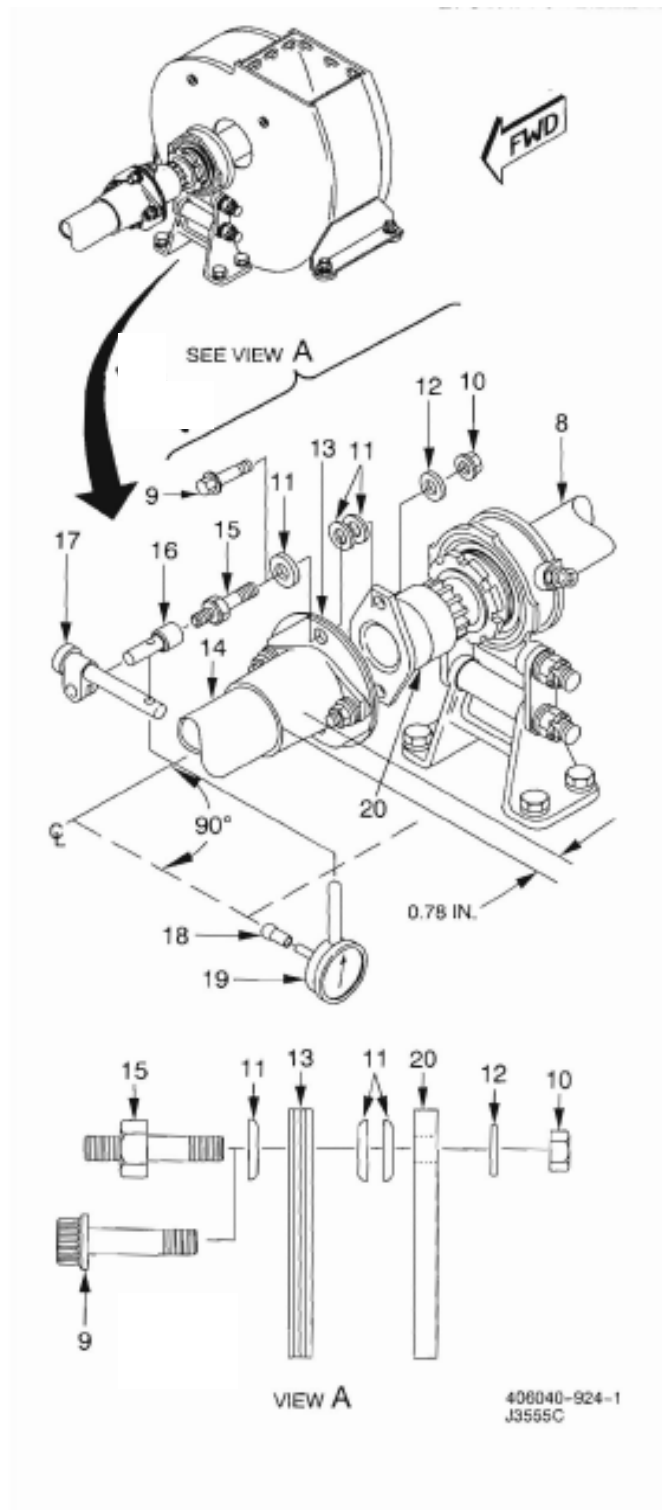
r. Using an inspection mirror to read dial indicator (B-44) (19), slowly rotate fan shaft (8) until indicator stem is contacting lower side of shaft and the indicator needle stops and reverses direction. By rotating the indicator face, zero the indicator at the reversal point. Continue to slowly rotate fan shaft (8) until indicator stem is contacting the upper side of the shaft and the indicator needle again stops and reverses direction. Record reading.

v. If the disc pack coupling angle at either end of the fan shaft is less than the recommended minimum, the angle between the third driveshaft and first segmented driveshaft may exceed the maximum allowable limits. Inspection of the angle between these shafts is required. If the angle is high, do not take action to align the shafts until steps are taken to optimize the fan shaft disc pack coupling. Remove shim from hanger mount and add shim to opposite hanger mount.

- Care shall be exercised in reading dial indicator. Stem shall always be more depressed (clockwise needle motion) at top of total indicator reading (T.I.R.) sweep than at bottom. This will avoid reversing curvature of driveshaft. With angles as small as 0.6°, the eye cannot readily detect whether angle is up or down.
- A maximum sweep indication at other than the 12 o'clock position is indicative of a lateral misalignment. Limited play between the hanger bracket hardware and the deck inserts allow for minor lateral corrections.

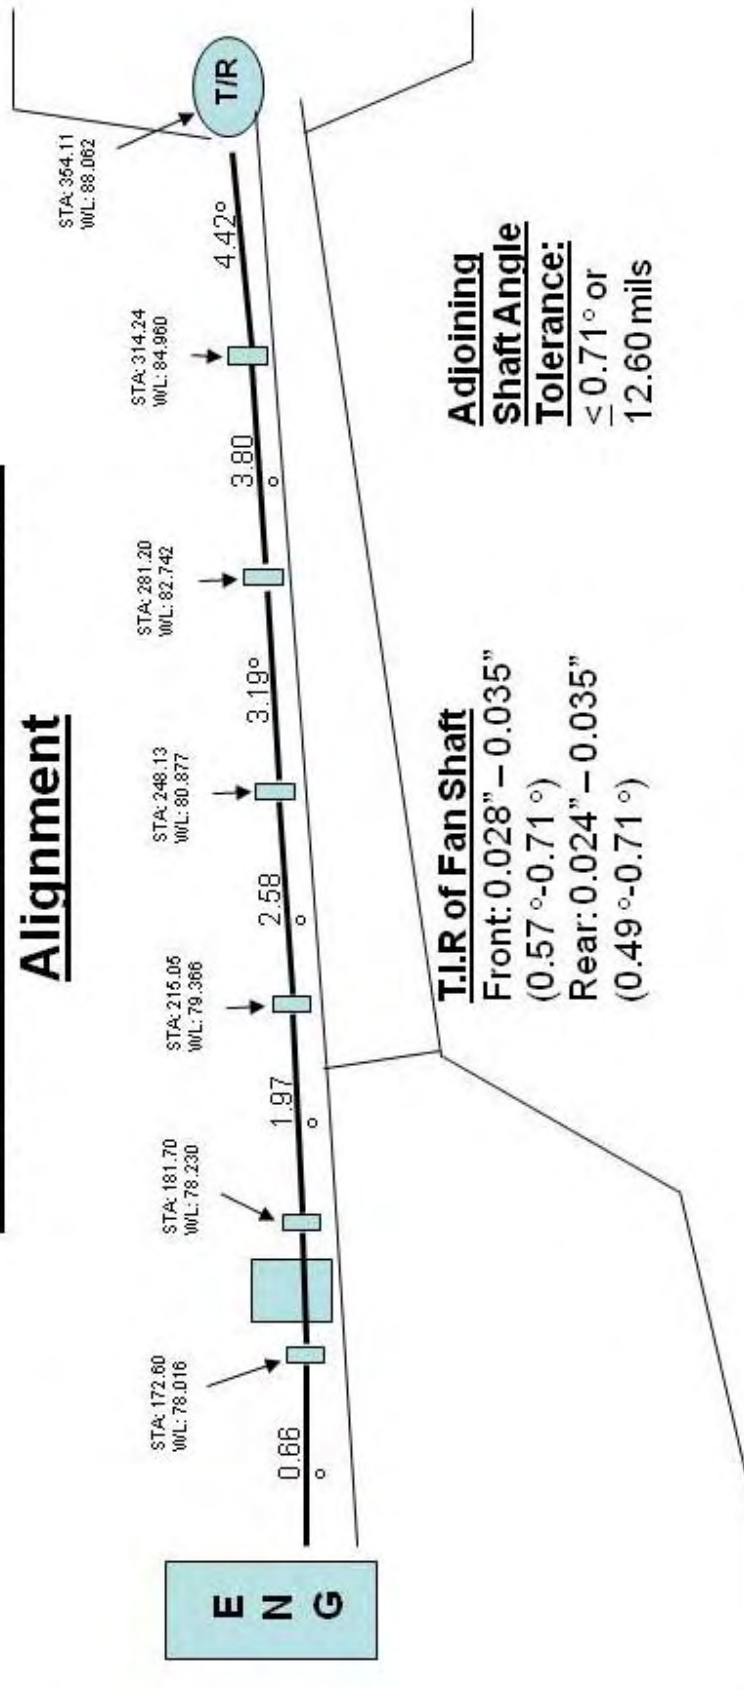
## OH-58D Tail Rotor Drive Shaft Alignment

- The angles listed above each shaft in the above figure are for demonstration only. These angles represent an optimum spread, and do not account for variations within each aircraft.
- Alignment and numbering of the shafts progress forward from the tail rotor gearbox. This numbering also holds true to the hanger bearings, brackets, couplers, etc....
