Addendum to H-58-14-AMAM-01 Engine Mount Fittings

Borescope Inspection shall be completed by a Technical Inspector

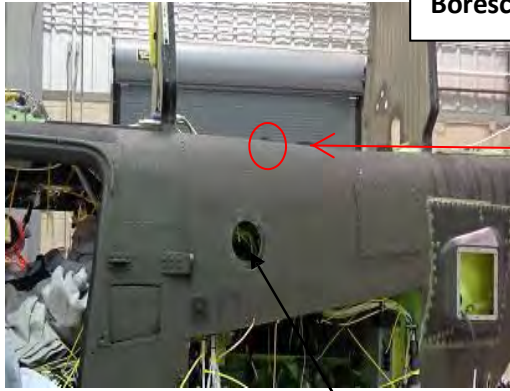
Access to the 406-030-142-101 (L/H Engine Mount Fitting)

Inspection area is interior to engine deck gunwhale adjacent to the bolt hole for the left and right forward lateral engine mount legs. Refer to TM 1-1520-248-23&P (EM0246) WP 0930 figure 2, item 28 for orientation.

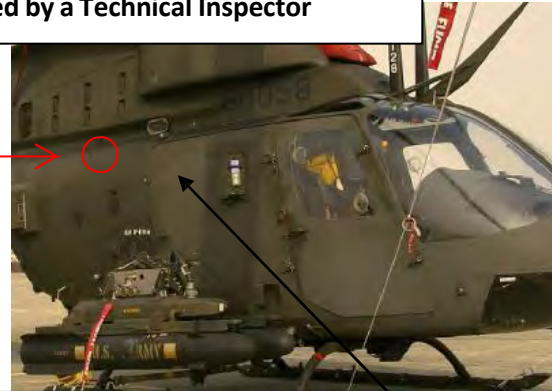
Access to the 406-030-142-102 (R/H Engine Mount Fitting) can be accomplished through the right hand Avionic Compartment door.

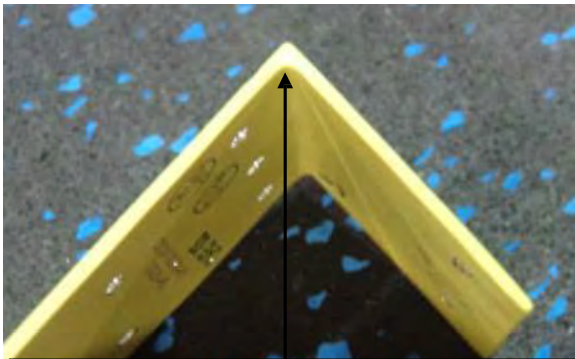
Conforming Fillet Radius

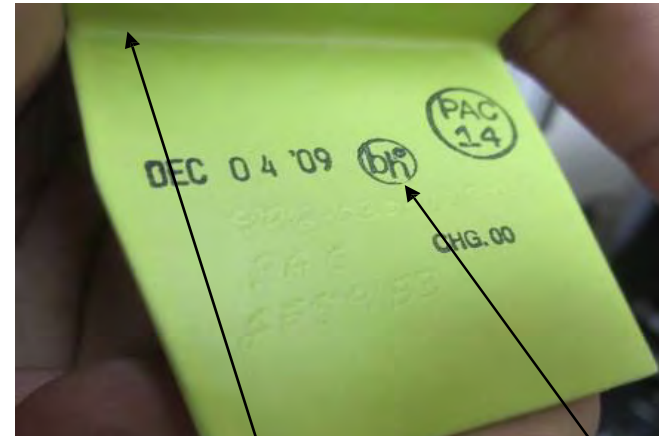
Conforming Fillet Radius and Bell Helicopter Stamp

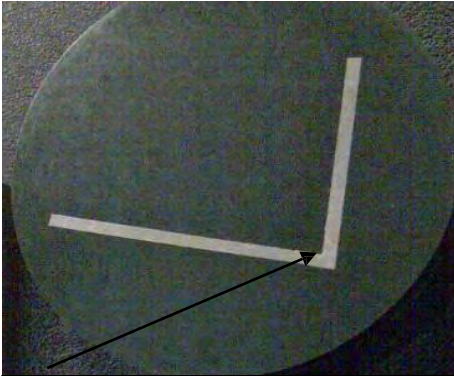
Non-Conforming: No Fillet Radius,
90 Degree sharp edge

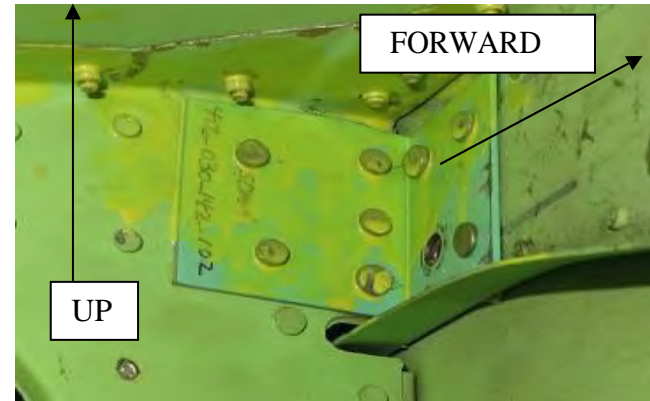
Non-Conforming: No Fillet Radius OR Bell Helicopter (bh) Stamp
(recent install)

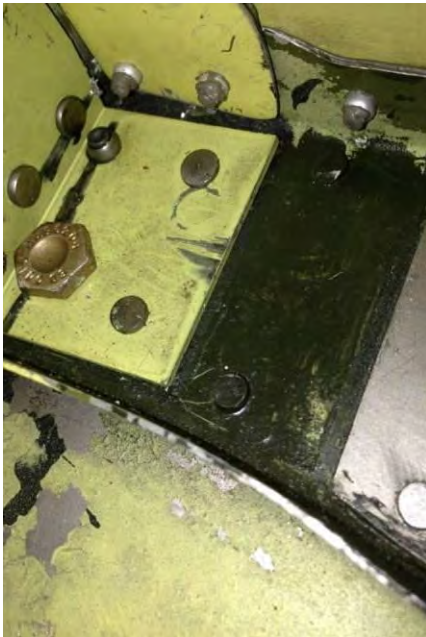
Non-Conforming Right
Hand Engine Fitting: No
Fillet Radius or (bh)
Stamp (recent install)

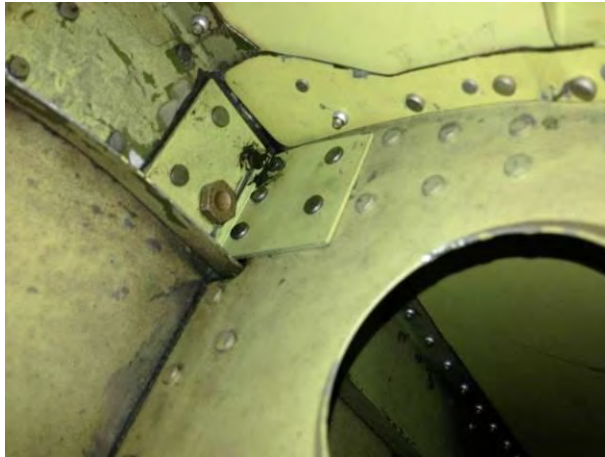
Non-Conforming Left
Hand Engine Fitting: No
Fillet Radius or (bh)
Stamp (recent install)

**If determination cannot be made, take photos and
contact POC listed in paragraph 13.1.2 of this
AMAM.**
