SUPPLEMENT TO H-58-11-ASAM-06 AN/ALQ-144 WIRING HARNESS

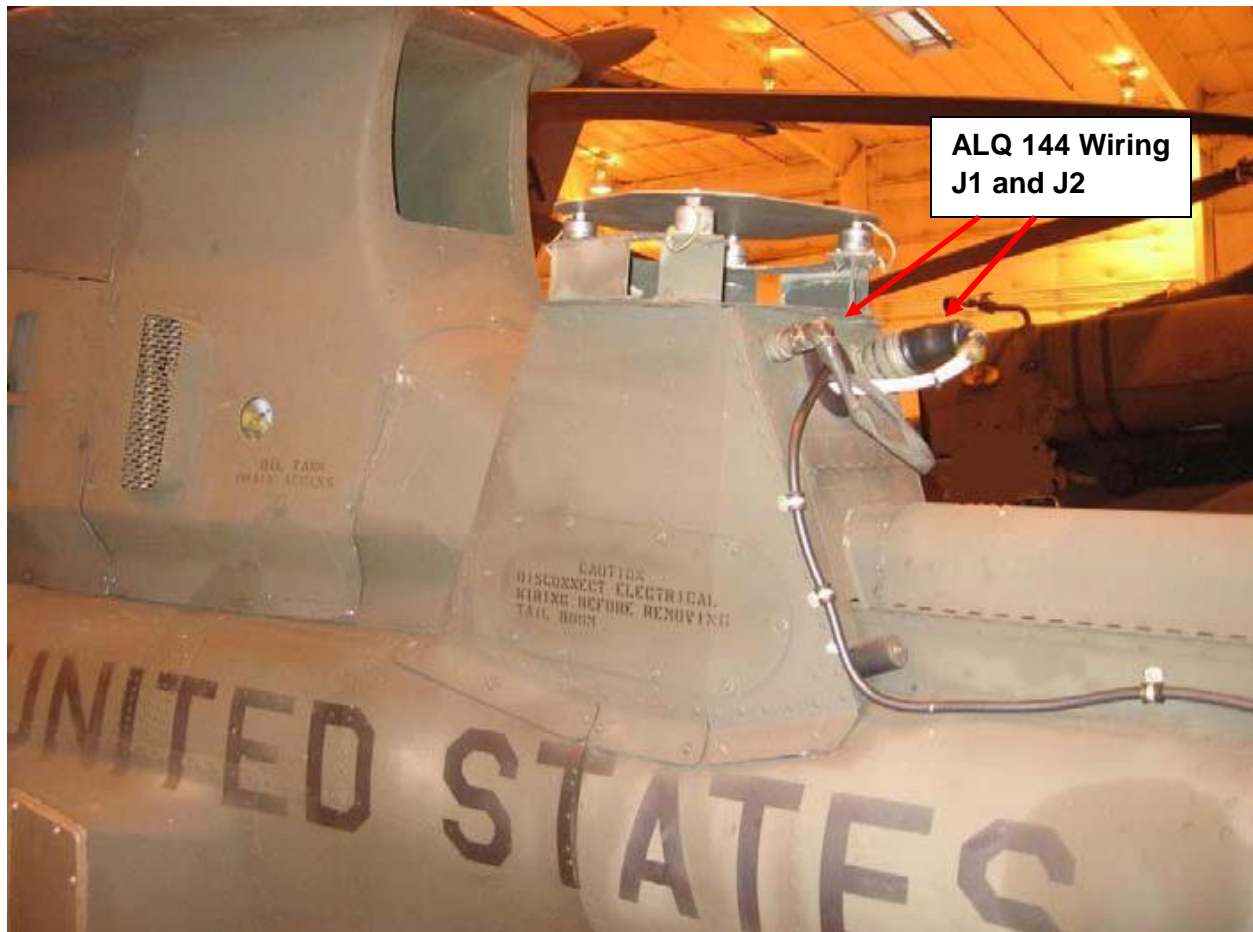
FIG 1: AN/ALQ-144 Countermeasures Set J1 and J2 Cables secured to "Dummy" receptacles.

The following Warning will be added to a future update to TM 11-1520-248-23, Task 7-4-3:

WARNING

Secure Excess Wiring Harness (J1 and J2) slack to prevent contact with aircraft Tail Rotor Drive Shaft."
